U.S. Fire Administration / National Fire Academy

*Coffee Break Training***Topic: Construction Elements**

Learning objective: The student shall be able to identify important elements that may affect structural performance.

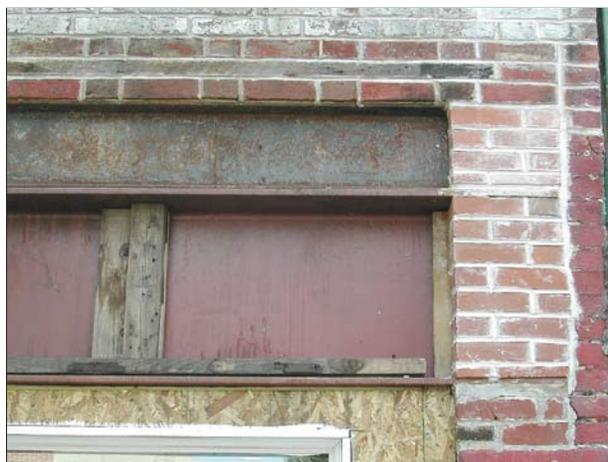
Every structural firefighter should study this picture closely. It illustrates a number of critical structural elements that can influence a building's performance during a fire.

First, notice the large steel I-beam above the window that serves as a lintel. The lintel transfers the loads from above the window to the adjacent wall, and eventually to the ground. At the far right side of the I-beam there is only one wythe of brick on the perpendicular exterior wall. (The unpainted brick only rests in the web of the I-beam.) If the beam were to elongate due to heating, it could push the brick wythe outward and cause a collapse.

Second, there is a smaller I-beam resting on top of the steel I-beam lintel. Since it is smaller—having less mass—it will be affected more readily by heat, and elongate at a different rate from the larger beam.

Third, the building is constructed of unreinforced masonry. Look at how the brick courses are arranged above the steel. The alternating brick ends that are visible are a common indicator of unreinforced masonry construction.

Fourth, the oriented strand board (OSB) sheathing at the bottom of the photograph shows that there is combustible construction in this building; that is additional fuel for a fire.

Finally, if you look very closely at the lower right hand corner of the picture, you will see there are two courses of brick already detached from the mortar. Only gravity and the compressive forces from the bricks above them are holding them in place.

This photograph was taken at a “postfire” building reconstruction project. These hazards subsequently have been hidden behind a cosmetic façade. Don't wait for a fire in your response district to expose you to similar hazards. Study the buildings in your response area.
