U.S. Fire Administration / National Fire Academy

Coffee Break Training

Topic: Maintaining Fire-Resistive Construction Elements

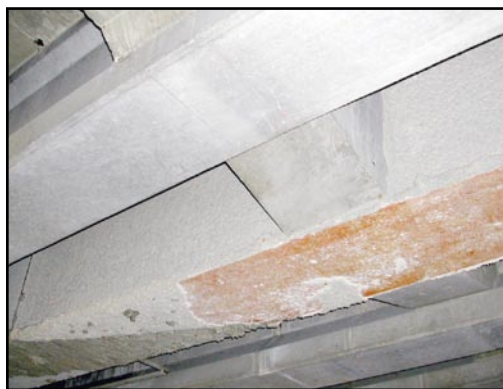
The photograph illustrates steel beams in an parking garage that are supporting a floor deck where heavy motor vehicles are stored.

Due to the building's size, the structural elements must be protected to a minimum one-hour fire resistance rating. In this particular example, the steel's fire resistance rating is achieved through concrete encasement.

The physical damage that has caused the concrete to separate from the steel has compromised the structure's fire-resistive integrity. Exposed steel is susceptible to failure when its average temperature reaches approximately 1,000 °F. In this case, weakening steel could cause sagging that might result in catastrophic structural failure.

Fire inspectors should be familiar with the many elements that make up fire-resistive construction, and if they observe damaged components, they should order corrective action.

The model fire codes authorize the fire inspector to require repairs to damaged fire-resistive assemblies. For additional information, refer to NFPA 1, *Uniform Fire Code*TM, Chapter 12, and the *International Fire Code*[®], Chapter 7.
